FAQs

PCB Fluorescent Light Ballasts in Schools

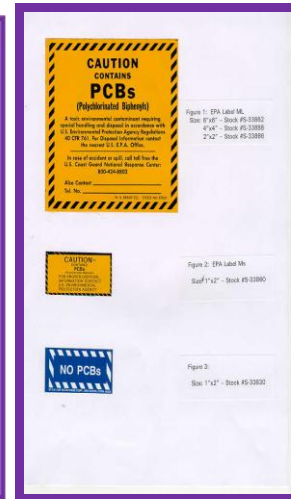
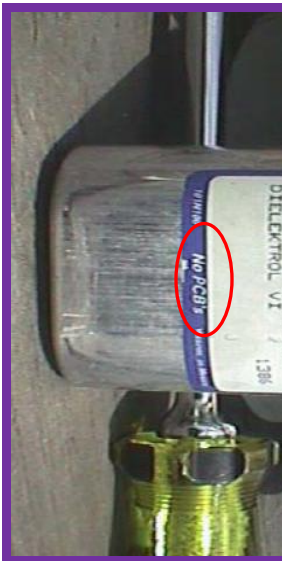
Each fluorescent light ballast manufactured (“manufactured”, for purposes of this sentence, means built) between July 1, 1978 and July 1, 1998 **that does not contain PCBs shall be marked by the manufacturer** at the time of manufacture with the statement, **“No PCBs”**.

The language of this label, ‘NO PCBs’ is required on any fluorescent light ballast manufactured before 1998 which does NOT contain PCBs. The size and color are not required. However, the absence of this language **MUST** be taken to mean that the item **DOES** in fact contain PCBs.

4. The inspector should note the date of manufacture posted on the ballast and look for markings indicating whether PCBs are present. If a ballast was manufactured between July 1, 1978 and July 1, 1998, it was required to be marked "No PCB" if it was made without PCBs. Such a marking definitively indicates that the ballast does not contain PCBs. However, if the ballast was manufactured during that time period or earlier and is NOT so marked, it must be assumed to contain PCBs and handled accordingly. (See photos)
